Specification

| Make | LINDE |
| Model | H16T-01 391 |

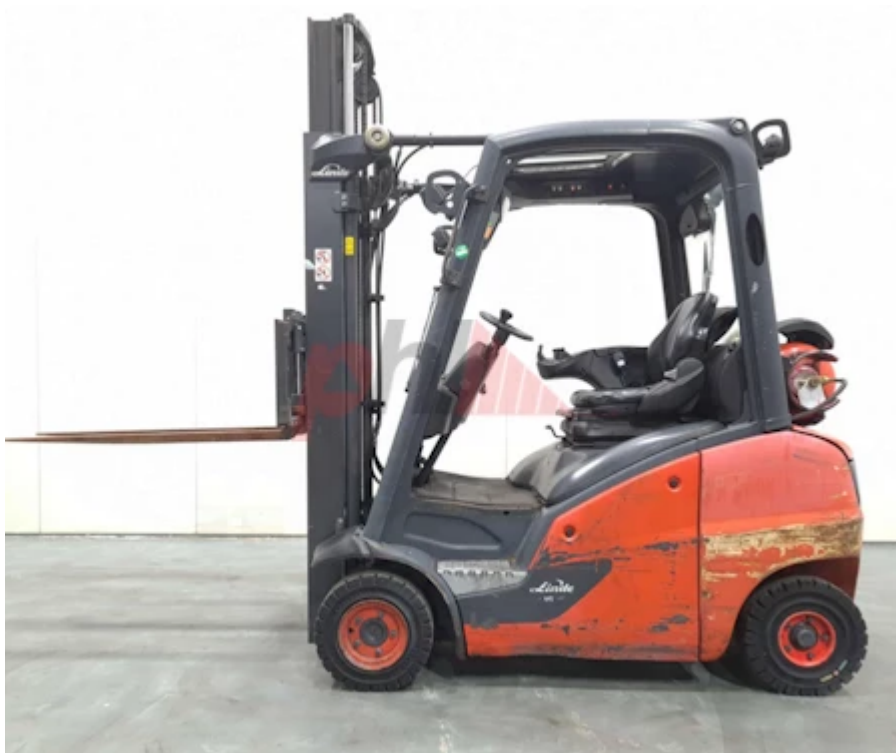
Visual

Appearance: Very good appearance for age

Mechanical Status: Very good working order
