Stock No 327209 Туре DIESEL Make LINDE Model H40D-02 394 Year 2015 Euromast 2W370 17667 Hours Capacity 4000 kg Lift height 3700 Values 3 Quality Rating 3

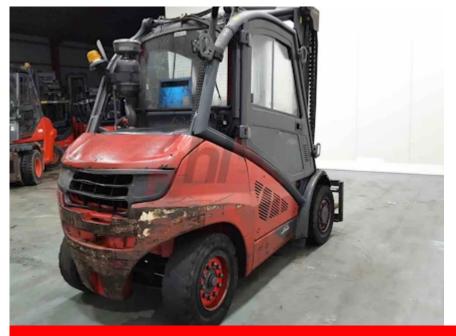
Appearance: Scruffy

Mechanical Status: Not tested
